Waste Audit Report

University of New South Wales

Kensington Campus

September 2010

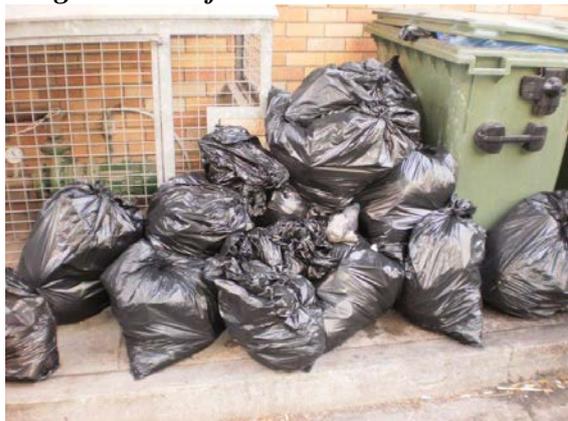
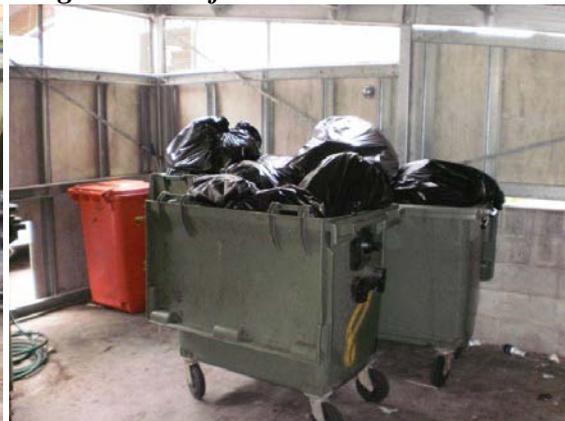
The issue of bin capacity is challenging, given the ‘transient’ nature of bins. For OH&S and ease of servicing, cleaners take the bins to the location where they are cleaning. Once the bin is full, they return it to the nearest bin station. This results in some bin stations having few bins in them and others having many. The number of bins in any one location can change on a daily basis. This means that when cleaners arrive with bags that need to be placed in the bins, sometimes there is no remaining capacity and bags are placed alongside the bins. It is recommended that a bin audit be carried out over a period of 2–3 weeks, tracking the number of bins in each bin station and how full they are prior to service. This will give a more accurate determination of the number of bins required in each bin station and assist with planning servicing requirements.

Image 1 – Overfilled bins.

Image 2 – Overfilled bins.

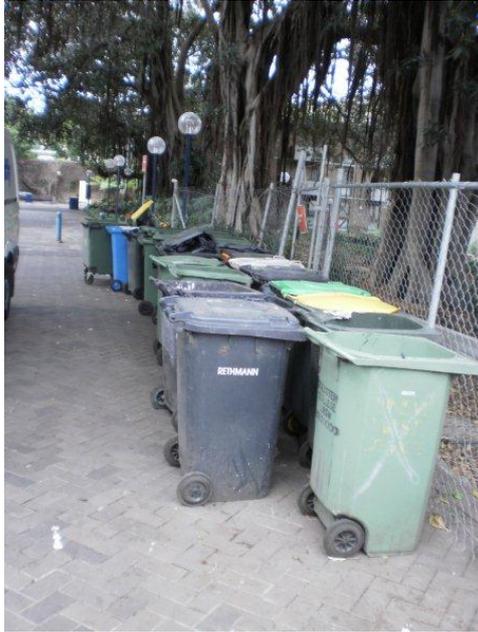
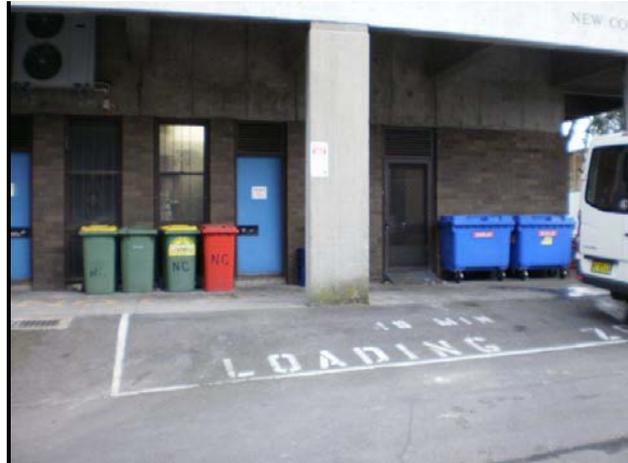
Due to the wide range of bin infrastructure, there appears to be some confusion over correct bin use. Access to bins appears to be an issue as well, with cleaners overfilling the accessible bins with the bins situated behind remaining empty. This could be addressed by reminding cleaners to move the full bins towards the back, and bring the empty bins forward. In some locations, the 660-litre bins could be placed sideways in a single row. This requires all cleaners being made aware of this when they are removing bins and bringing them back to the bin storage area.

Image 3 – Variety of bins.

Image 4 – Variety of bins.

There is an opportunity to review the bins to replace damaged or old bins and make the bin fleet relatively consistent. It appears that where yellow lidded recycling bins are provided, cleaners are utilising them correctly as recycling bins.

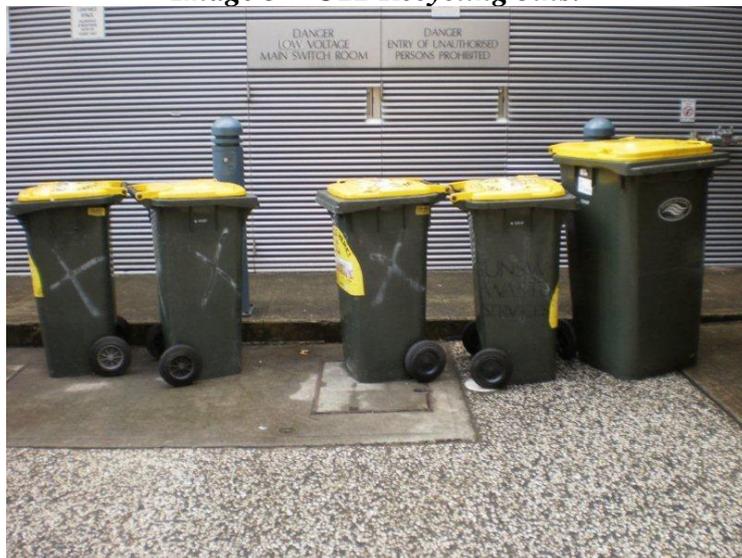
Image 5 – U22 Recycling bins.

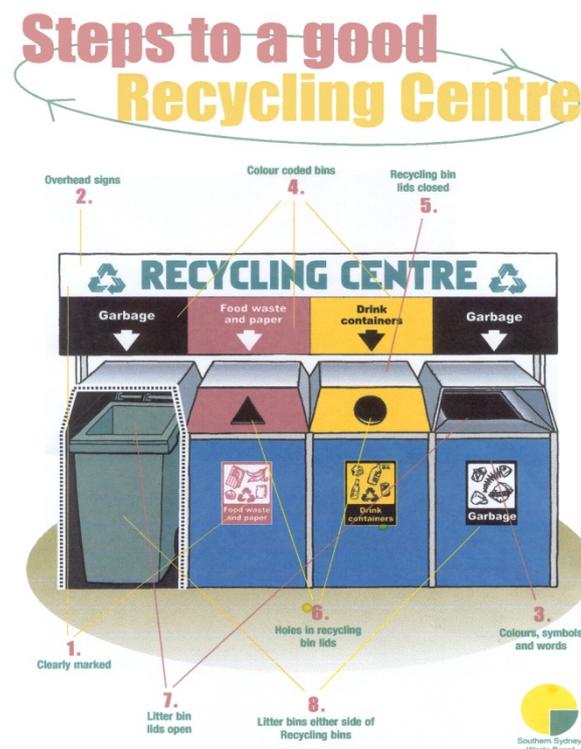
The diagram below shows a public place recycling station with all its features.
